**AN IN-DEPTH PORTRAIT OF THE CURRENT DELTA
LEVEE CONDITIONS AND CHALLENGES FOR
IMPROVEMENT**

**STUDY PERFORMED BY KLEINFELDER-GEOMATRIX TEAM UNDER
CONTRACT TO UNITED STATES ARMY CORPS OF ENGINEERS,
SACRAMENTO DISTRICT**

CALFED Levee Stability Program

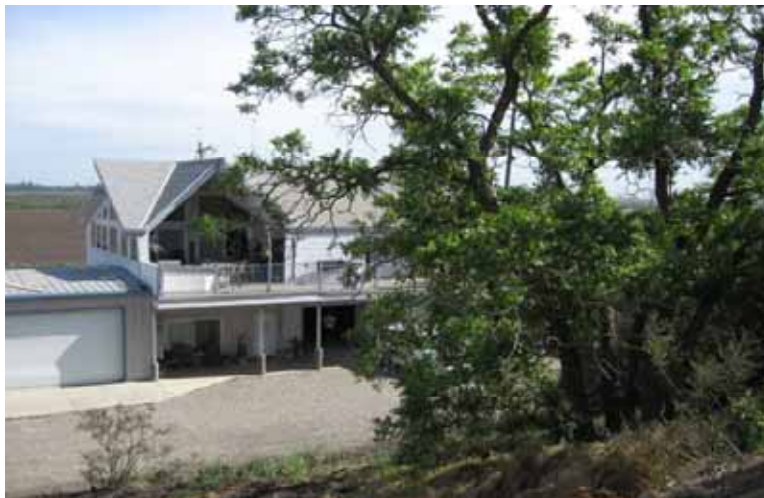
Home near toe of levee - landowner requested trees preserved

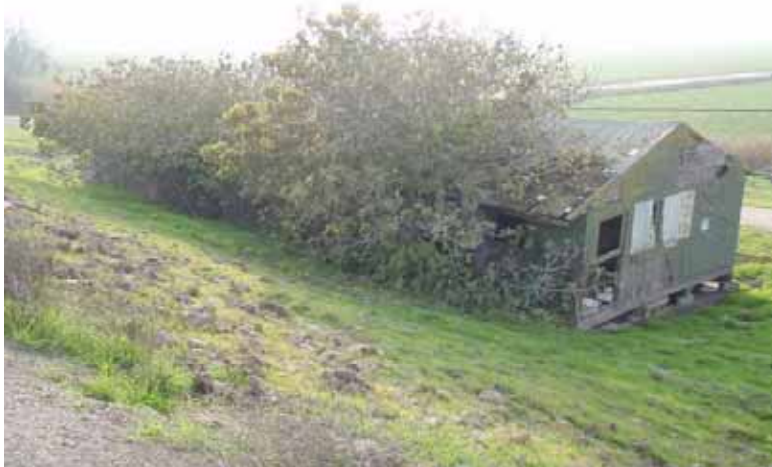
Down slope view of old historical labor camp housing at toe of levee slope

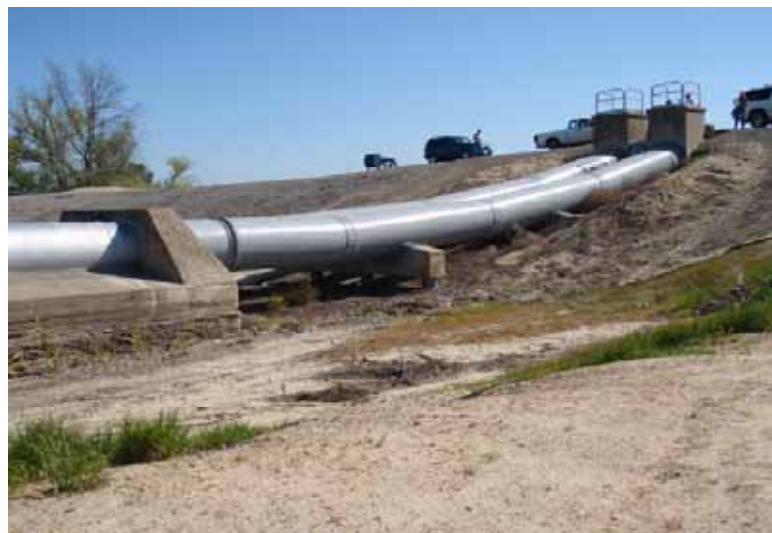
Northeastern landside view of EBMUD aqueduct penetration into the levee

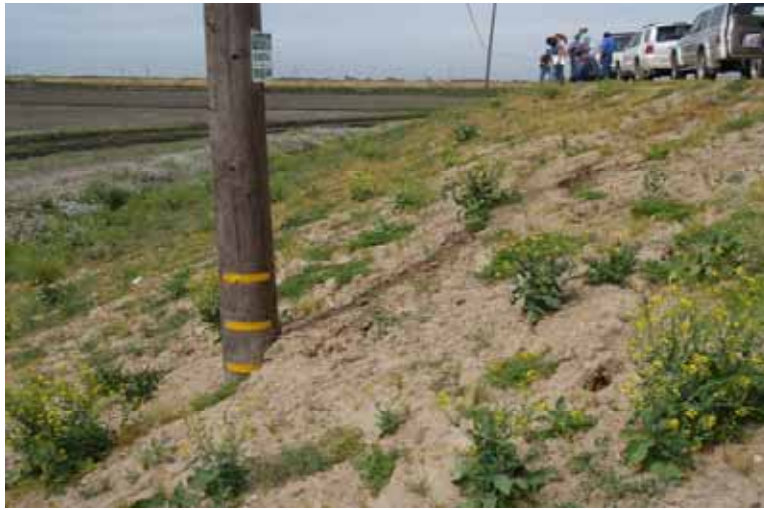
**Northern view of landside conditions in repaired area
Note: Surface cracks, erosion gullies at mid slope**

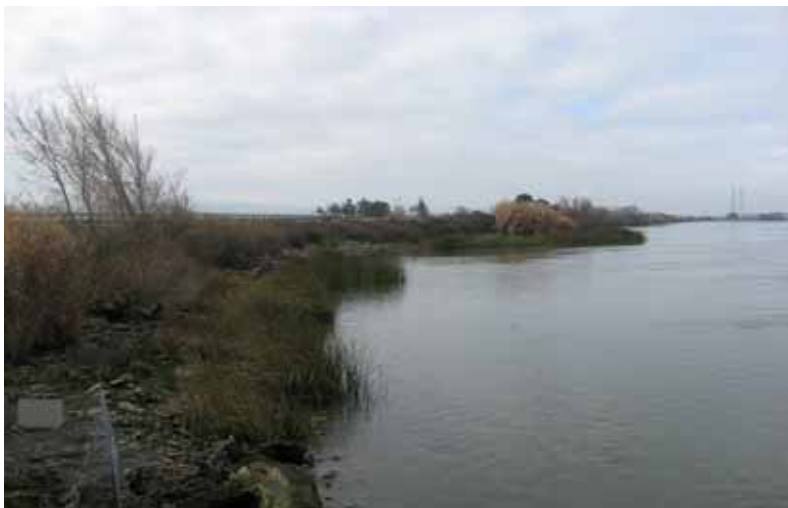
**Overview of site, looking downstream from intake
Heavy erosion along Sacramento River requires repair**

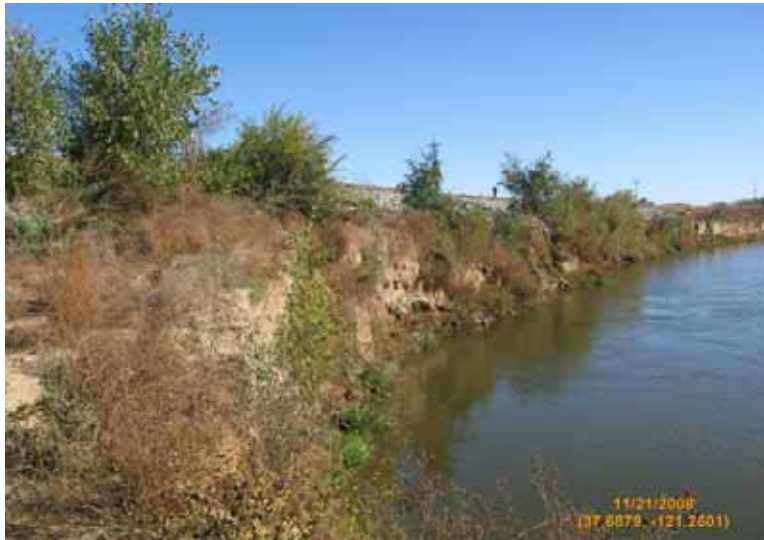
Erosion in the waterside slope

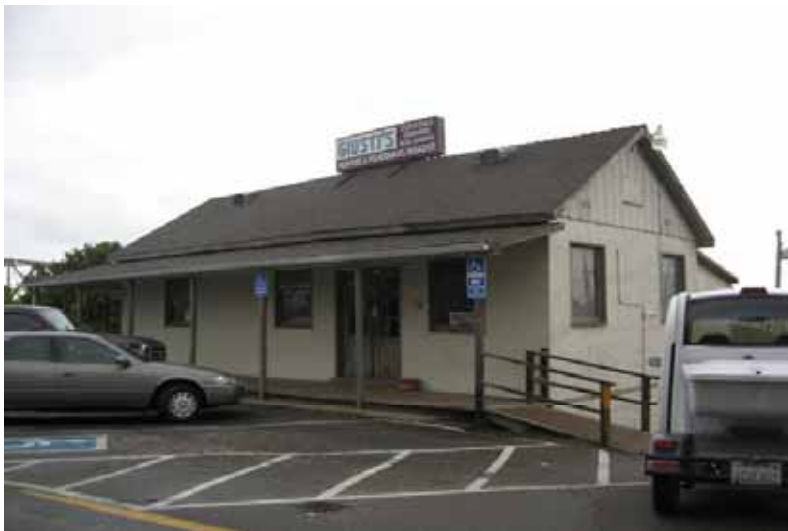
Upgrade to PL 84-99 not possible due to presence of the structure on top of the levee

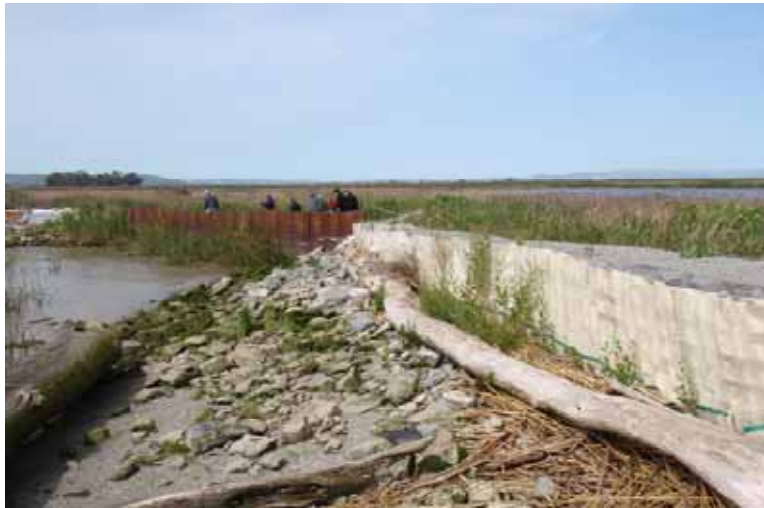
Western view of the waterside conditions along the Sacramento River. Sheet piles and a cellular wall filled with crushed gravel were installed to prevent overtopping

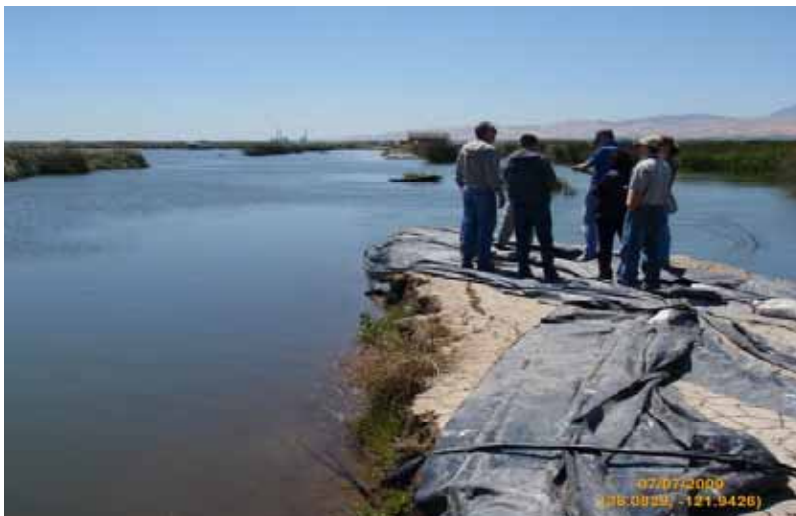
Southern view of the break in Blue Bird Road with other side of break in background (Area was repaired previously as indicated by the remaining sand bags and tarps)

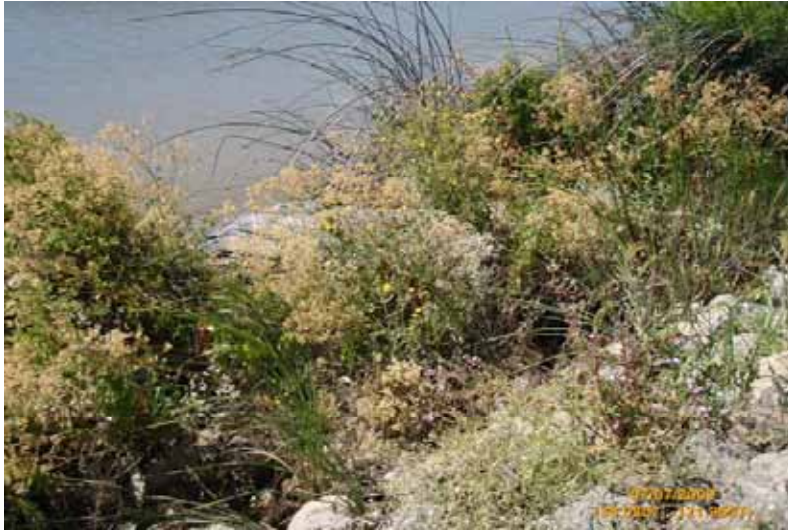
**View of levee failure caused by ongoing subsidence
Note: Levee was set back away from failure**

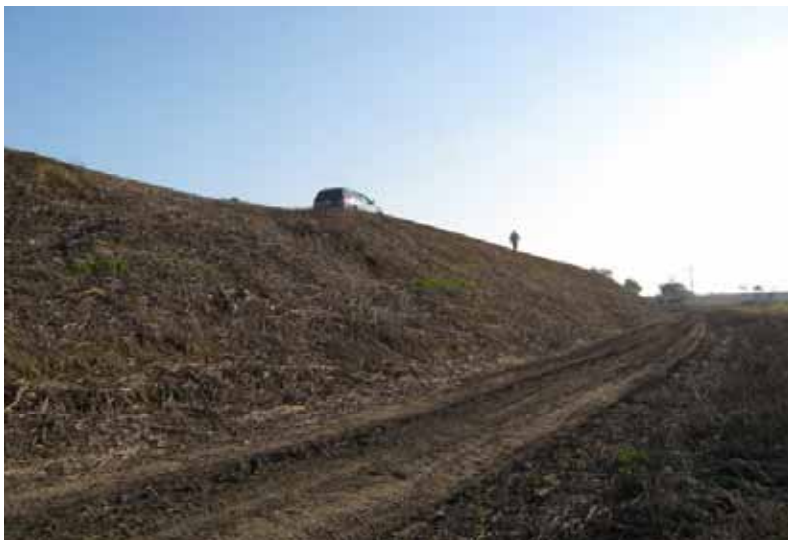
Steep landside levee slope

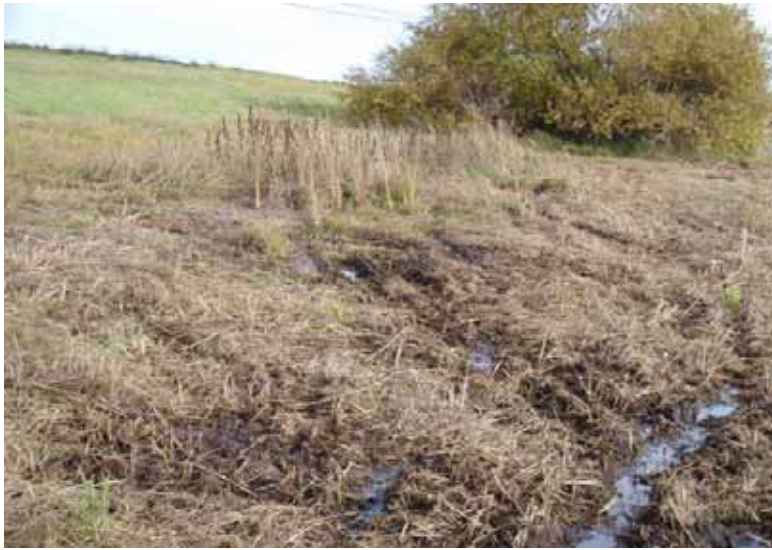
Southern view of levee slope where wet spots are noticeable and indicate seepage

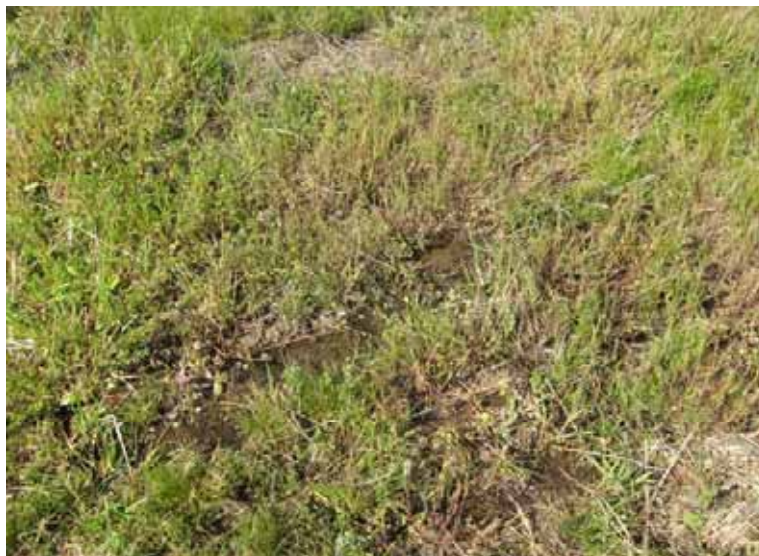
Standing water and wet ground on the landside slope as a result of seepage

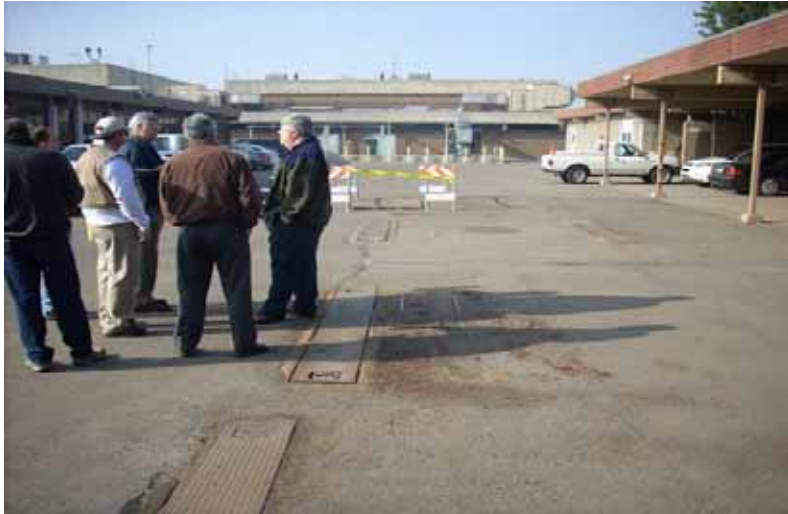
Northwest view of possible point of internal inundation from the underground effluent lines (under grates in pavement) leading into the head works

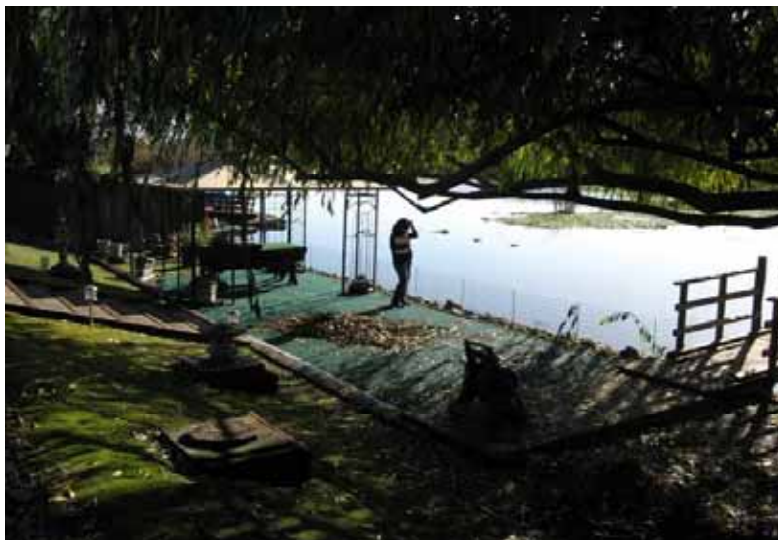
A homeowner backyard that spans the levee

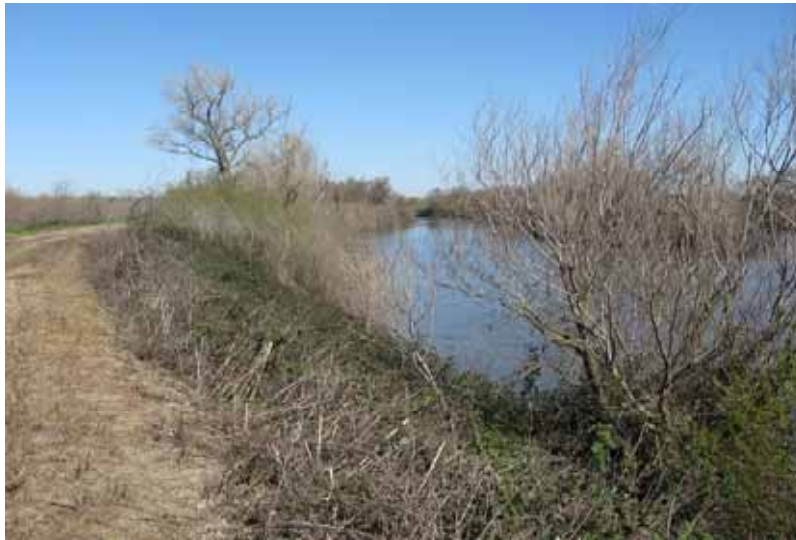
Waterside condition in area to be degraded (will be cut down approximately 9 feet)
