2009 California Water Conference:
Changing Tides in the Inland Sea – A Confluence of Challenges and Opportunities

Incorporating hardened vegetated buffers along levees

Lower Puyallup River

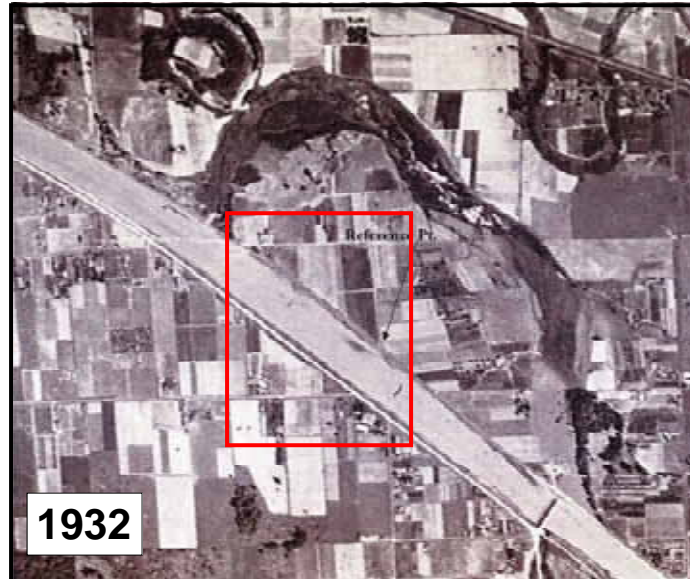
Channel and floodplain confinement in the early 1900s

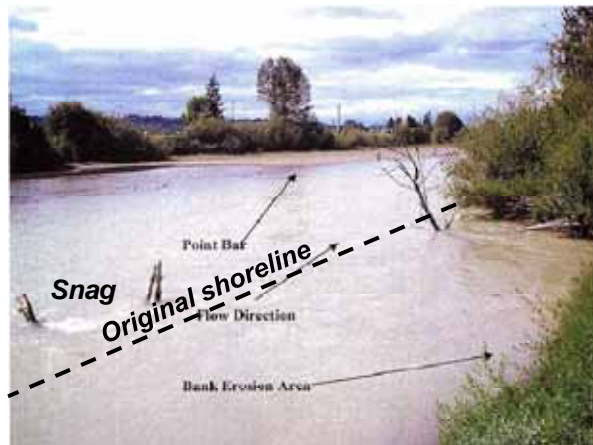
Project Site 2004 (Figure 3, CHE 2005)

**Problem:
Bank erosion threatening
critical levee**

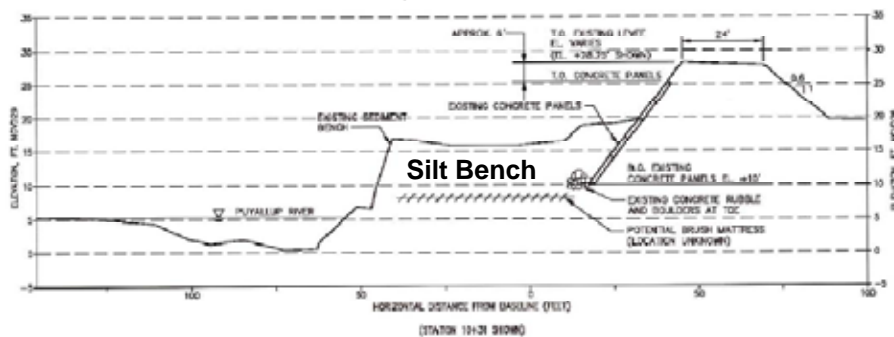
Historic North Levee Structure

Construction of a “silt bench” along inboard side of historic levee was critical element in protecting toe of levee

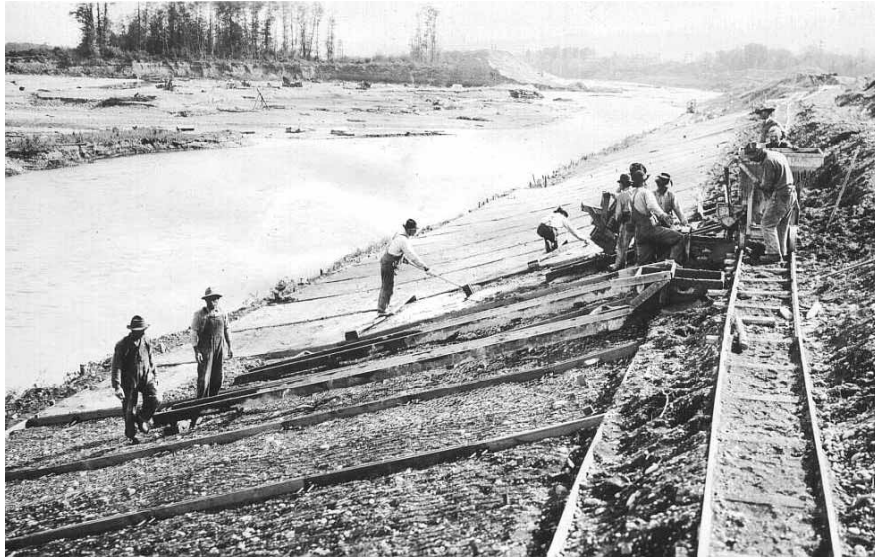
Historic elements: concrete slope

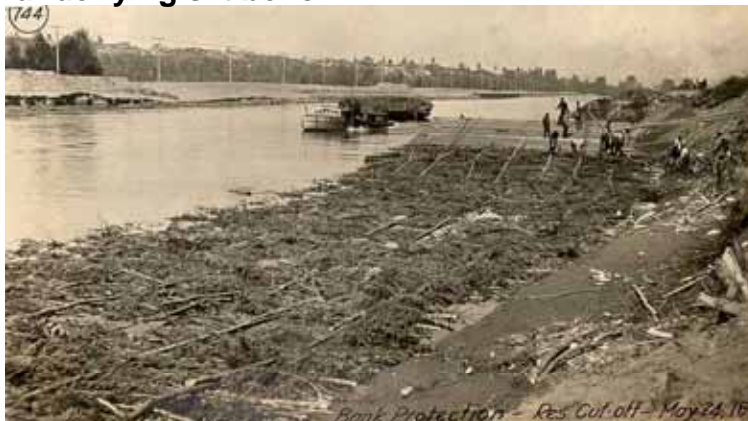
**Historic elements: Cedar brush matting
underlying silt bench**

**It is unclear regarding the extent of this work –
there is no direct evidence from corings or bank
stratigraphy it was done at site.**

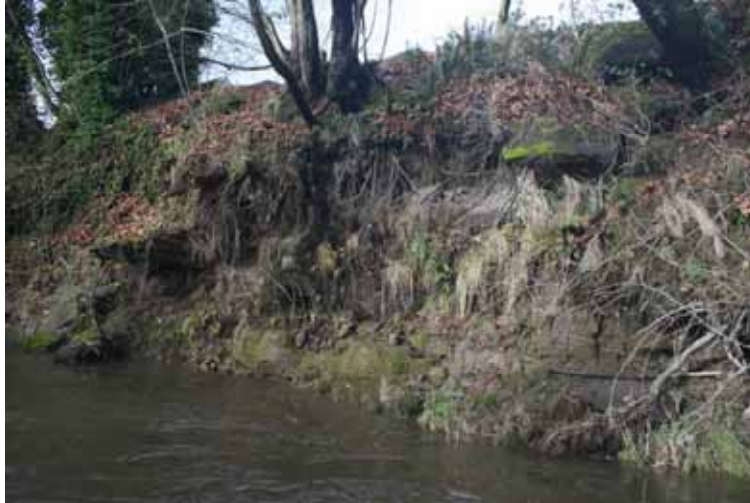
Eroding bank into historic concrete armoring
Right Bank of Puyallup River 01/11/08:

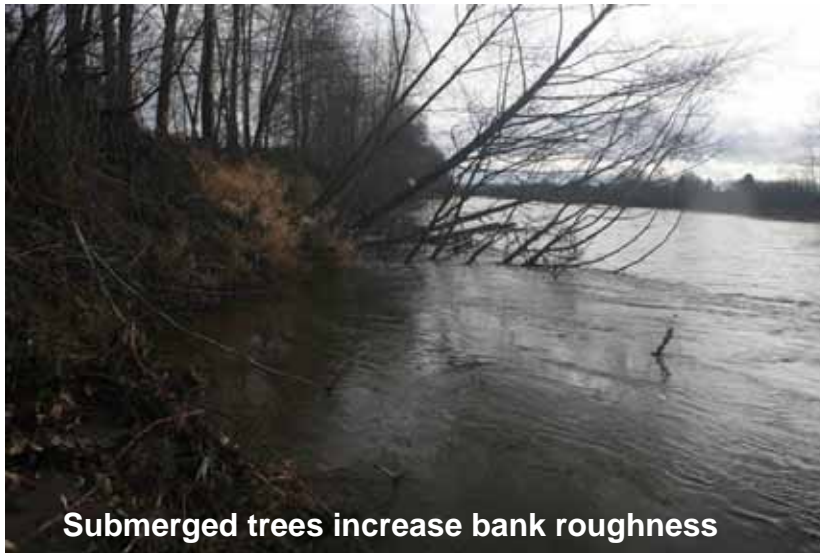
Bank Erosion, slumping

Project Site 01/11/08: looking upstream at bank slump

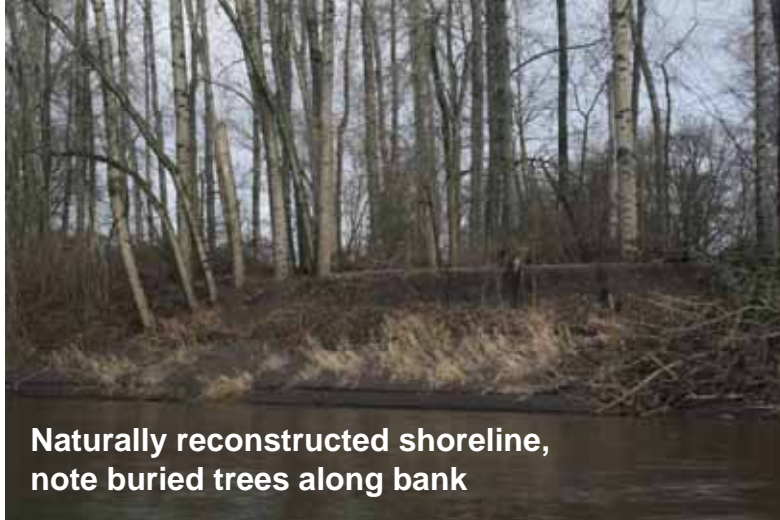
**Right Bank of Puyallup River 01/11/08:
Naturally re-constructed silt bench shoreline**

**Naturally reconstructed shoreline,
note buried trees along bank**

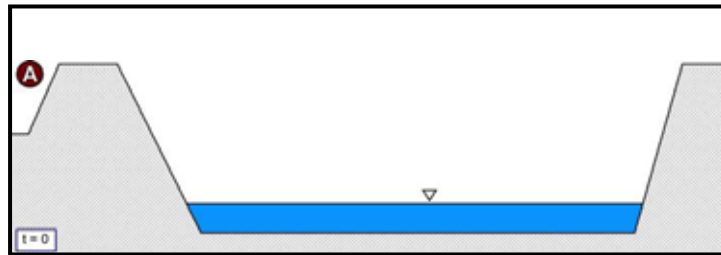
Geomorphic Evolution of Puyallup Silt Bench

Flood conveyance channel oversized relative to dominant flows

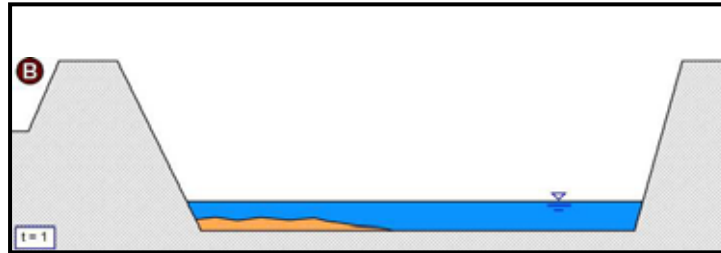
Geomorphic Evolution of Puyallup Silt Bench

Sedimentation and bar formation resulting from over-sized channel

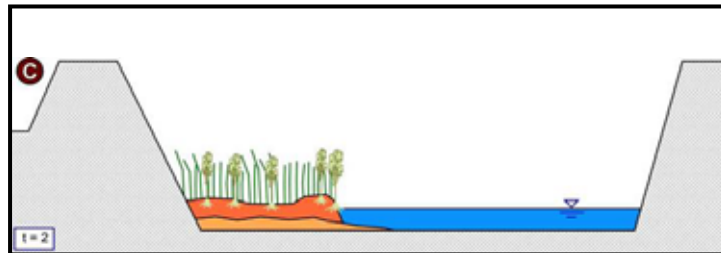
Geomorphic Evolution of Puyallup Silt Bench

Plant colonization and sedimentation

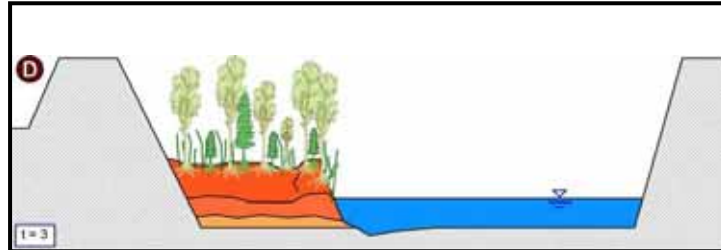
Geomorphic Evolution of Puyallup Silt Bench

Plant growth, accelerated sedimentation, and first signs of toe erosion

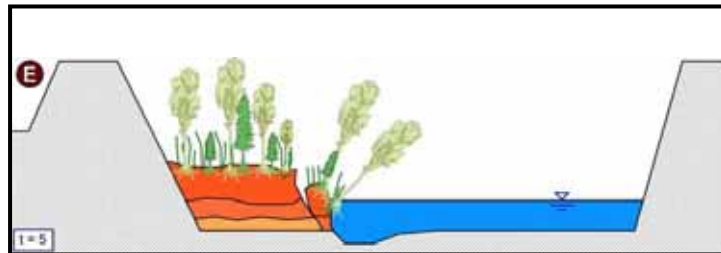
Geomorphic Evolution of Puyallup Silt Bench

Toe erosion under-cuts bank, tension cracking and slumping

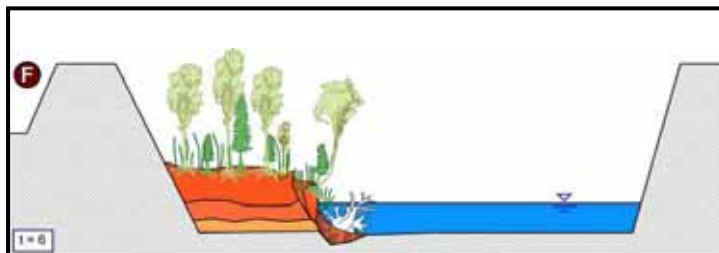
Geomorphic Evolution of Puyallup Silt Bench

Tree falls into channel forming snag that adds toe roughness. Fallen tree straightens out getting “pistol butt trunk”, snag and vegetation reverses erosion

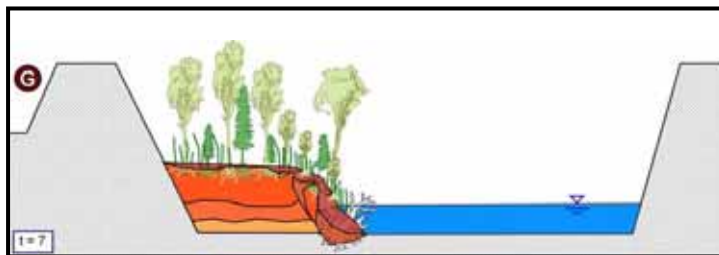
Geomorphic Evolution of Puyallup Silt Bench

Colonizing vegetation further roughens bank, adds root cohesion and accelerates bank re-construction

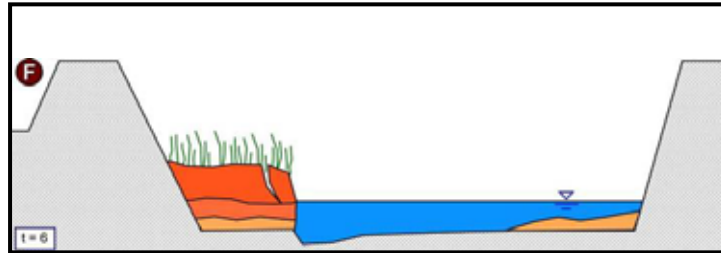
Geomorphic Evolution of Puyallup Silt Bench

With no riparian trees, bench is at elevated risk of erosion

Without cohesion and roughness provided by trees bank erosion continues - channel shifting occurs similar to historic changes in location of point bar

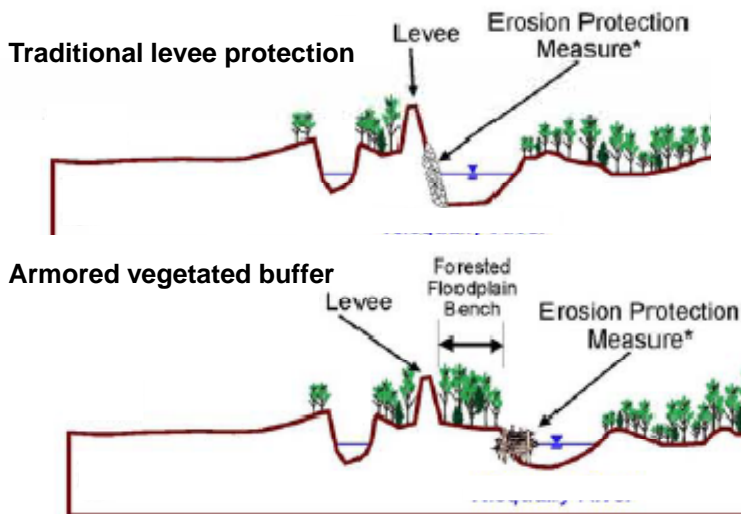
Vegetated buffers offer additional protection and environmental benefit

* Erosion Protection Measure: complex dynamic revetments, engineered logjams

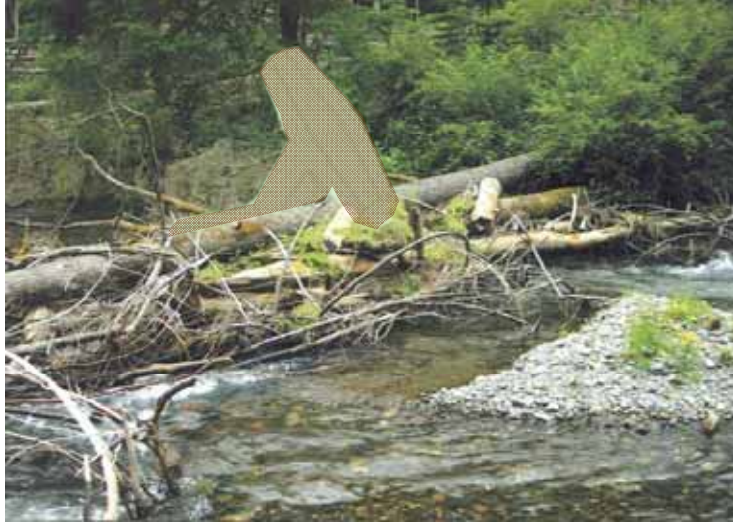
Relatively easy to incorporate wood debris

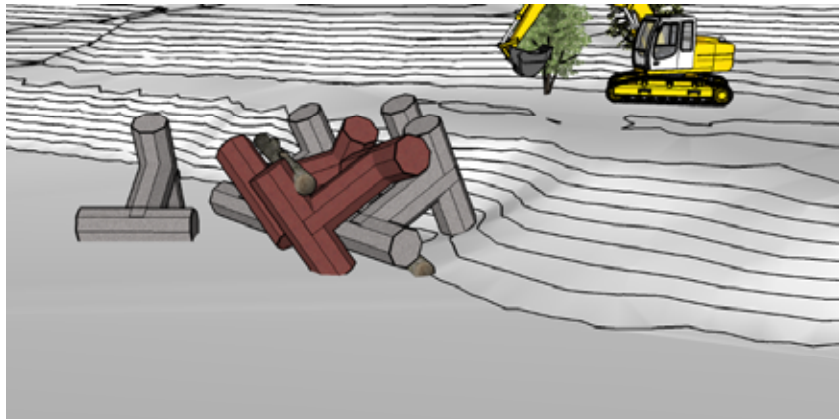
Construction visualization

**Construction can be accomplished all with
single large excavator**

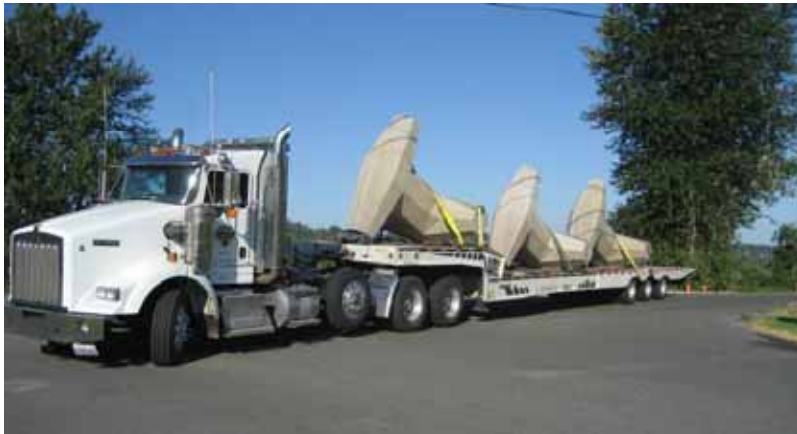
Construction

**Ground delivery
Crew of 2
1 450 Excavator**

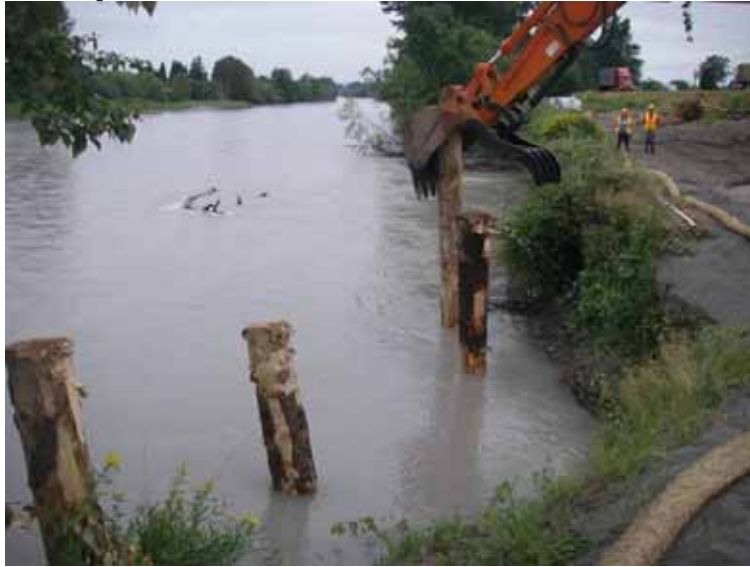
Pile placement

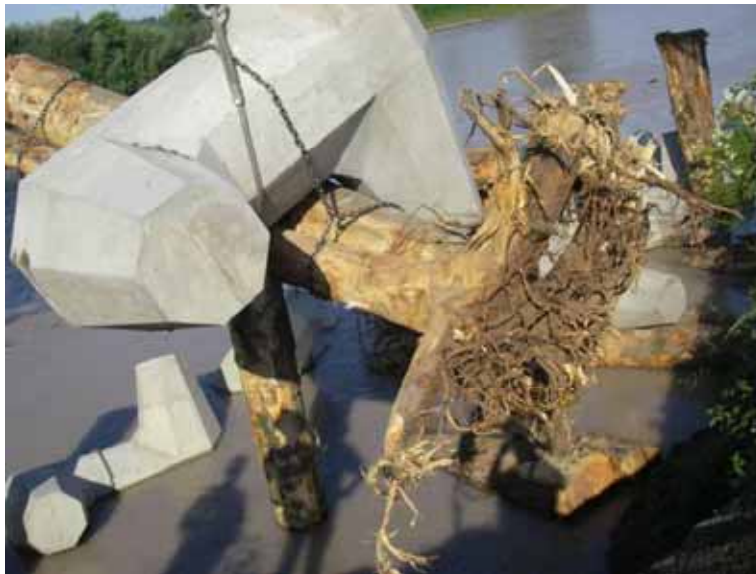
Dolo and timber placement

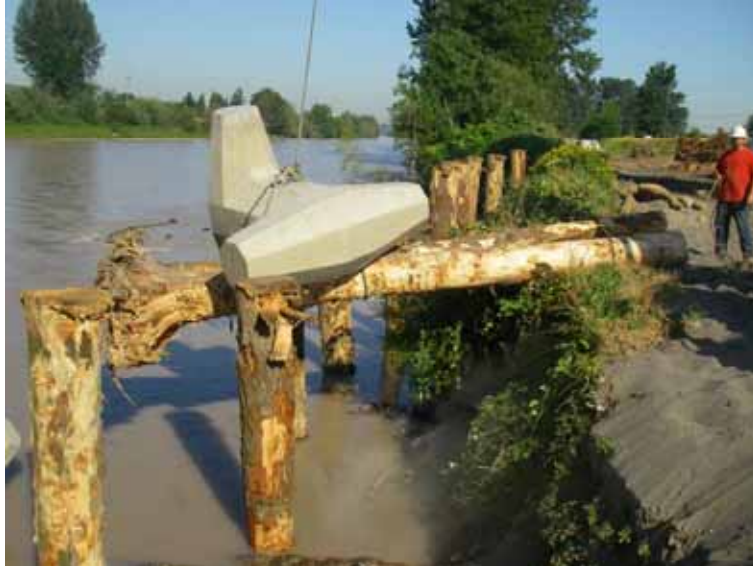
Dolo and timber placement

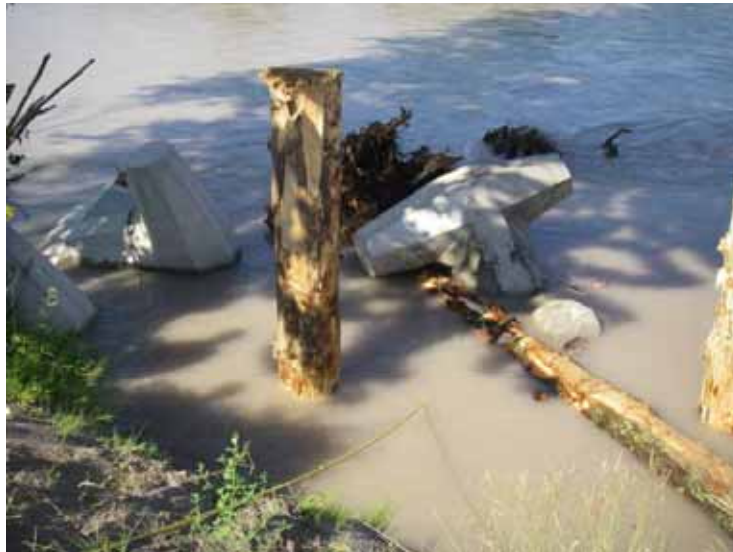
Dolo layer one

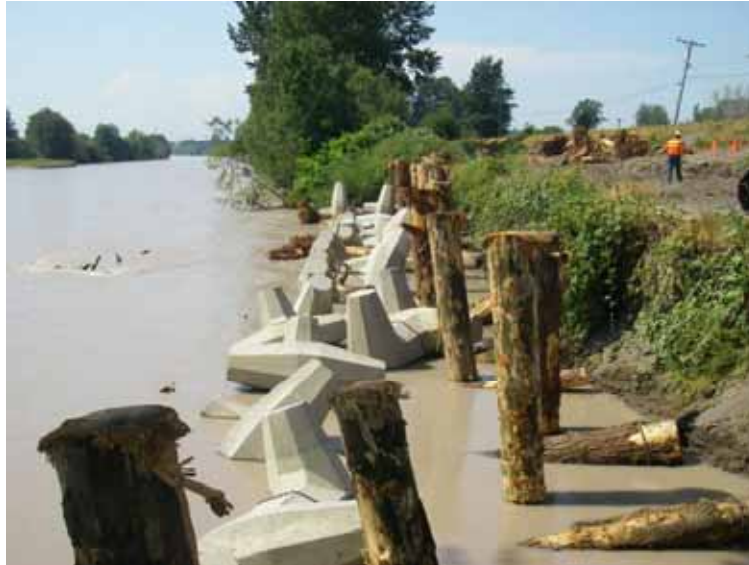
Dolo layers two and three

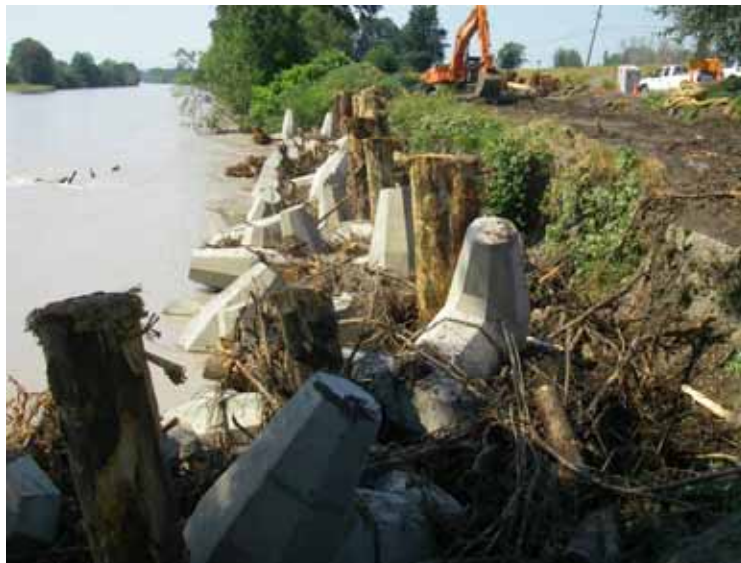
Dolo layer four

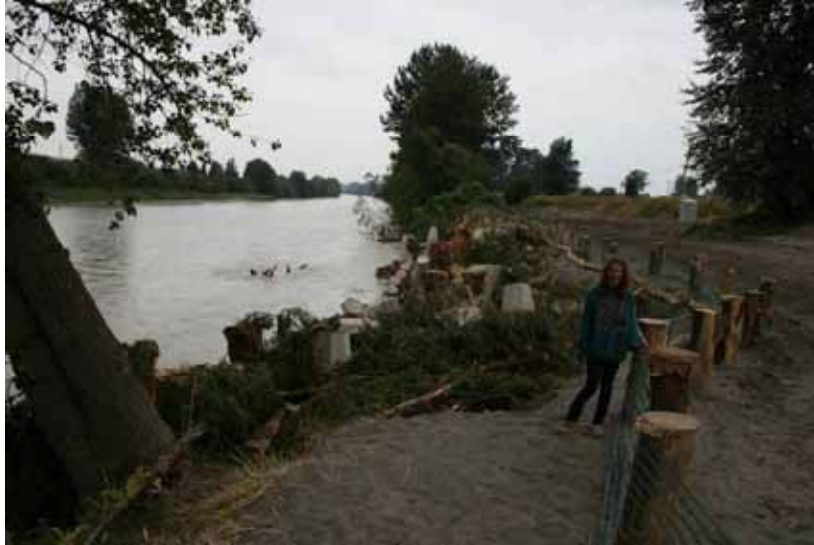
Completed revetment

Project completed on time and on budget, saving over \$1M compared to other alternatives.

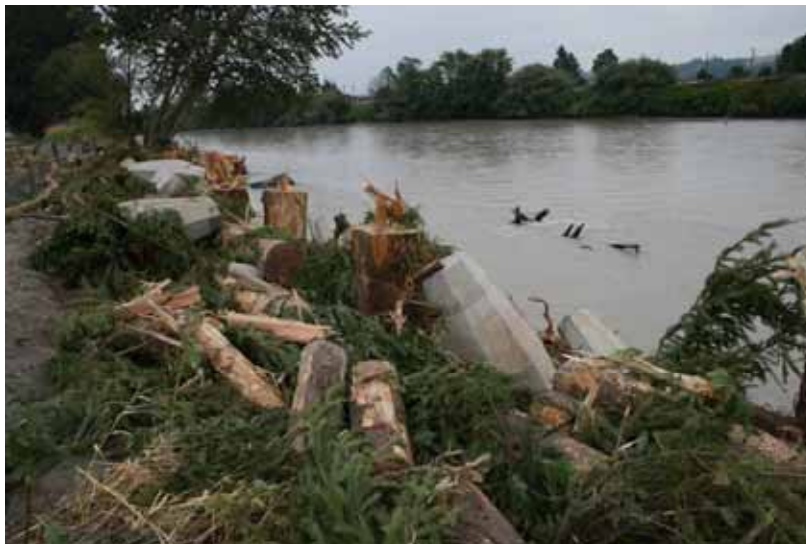
Completed revetment
